Manhole Inspection Summary

Manhole # S53C__046MH

Insp Date: **6/20/08 9:52 AM**

Location Address: **rear 11 n clinton st**

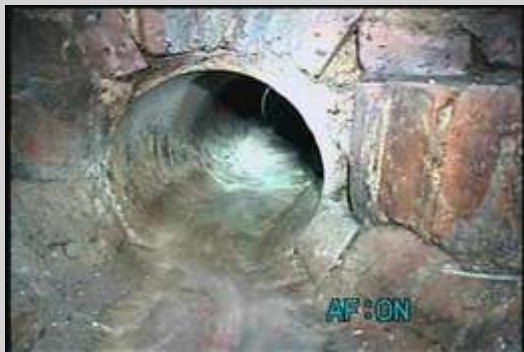
12 O'Clock Outflow

8 in. Circular Gravity Sewer
Pipe Out @ 12 O'Clock

Pipe Material: **Clay** ☐ Pipe Lined

Invert Depth: **8.03** (ft.) Flow Characteristics: **Slow**

Deposits: ☒ None ☐ Mud ☐ Sludge ☐ Debris ☐ Grease

Infiltration: **None** Pipe Seal Cond: **Unknown**

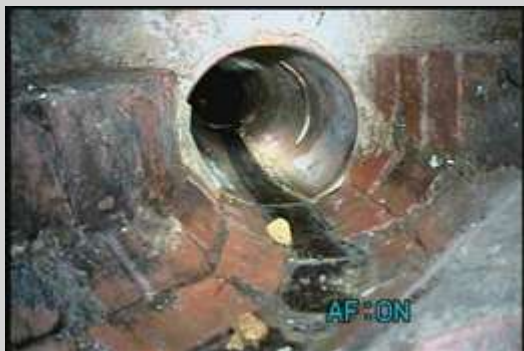
3 O'Clock Inflow

6 in. Circular Gravity Sewer
Pipe In @ 3 O'Clock

Pipe Material: **Clay** ☐ Pipe Lined

Invert Depth: **7.81** (ft.) Flow Characteristics: **Fast**

Deposits: ☒ None ☐ Mud ☐ Sludge ☐ Debris ☐ Grease

Infiltration: **None** Pipe Seal Cond: **Unknown**

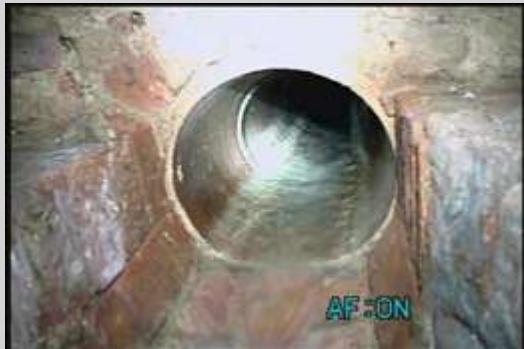
6 O'Clock Inflow

8 in. Circular Gravity Sewer

Pipe In @ 6 O'Clock

Pipe Material: **Clay** ☐ Pipe Lined

Invert Depth: **7.66** (ft.) Flow Characteristics: **Fast**

Deposits: ☒ None ☐ Mud ☐ Sludge ☐ Debris ☐ Grease

Infiltration: **None** Pipe Seal Cond: **Unknown**

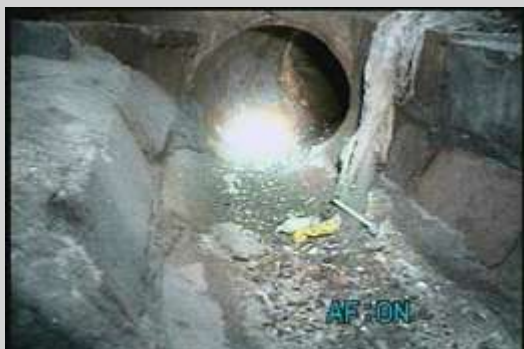
9 O'Clock Inflow

8 in. Circular Gravity Sewer

Pipe In @ 9 O'Clock

Pipe Material: **Clay** ☐ Pipe Lined

Infiltration: **None** Pipe Seal Cond: **Unknown**
